**PRELIMINARY ASSESSMENT/
VISUAL SITE INSPECTION**

**ORCHEM, INC.
(FORMERLY ASHLAND CHEMICAL COMPANY)
CINCINNATI, OHIO
OHT 400 011 615**

FINAL REPORT

**U.S. ENVIRONMENTAL PROTECTION AGENCY
Office of Waste Programs Enforcement
Washington, DC 20460**

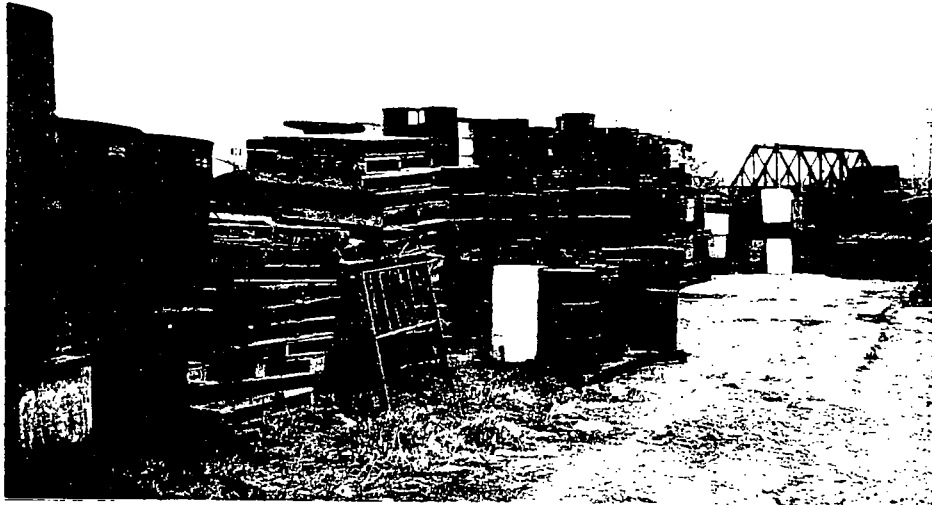
Photograph No. 1

Observations: During the VSI, the area contained at least 300 55-gallon drums and various other sized containers (see Photograph Nos. 1 through 5). Orchem stated that the drummed materials were product. Many of the drums, stacked three high in most areas, were severely rusted and appeared to have been onsite for an extended period of

time. The concrete pads throughout the area were severely cracked and stained. By slightly pushing various drums, PRC determined that practically all the drums were full of liquid materials. PRC also observed a milky white material at the base of the truck loading dock (see Photograph No. 6). No stained soil was noted in the area.

Location: SWMU 1

Recommendations: PRC recommends that soil borings be performed throughout this unit, with sampling of soil and ground water. Samples should be analyzed for hazardous constituents. OEPA should continue to monitor Orchem's actions concerning the 55-gallon drums stored at the facility. Analysis and disposal of these materials should be conducted in an environmentally sound manner.

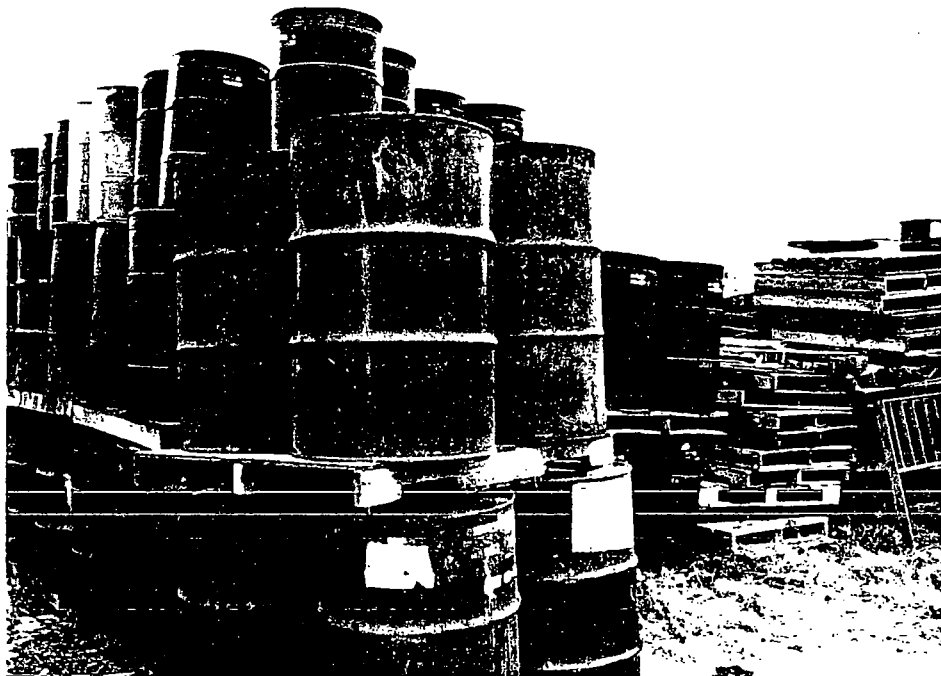
Photograph No. 2

Description: Deteriorating drums in the Operations and Storage Area.

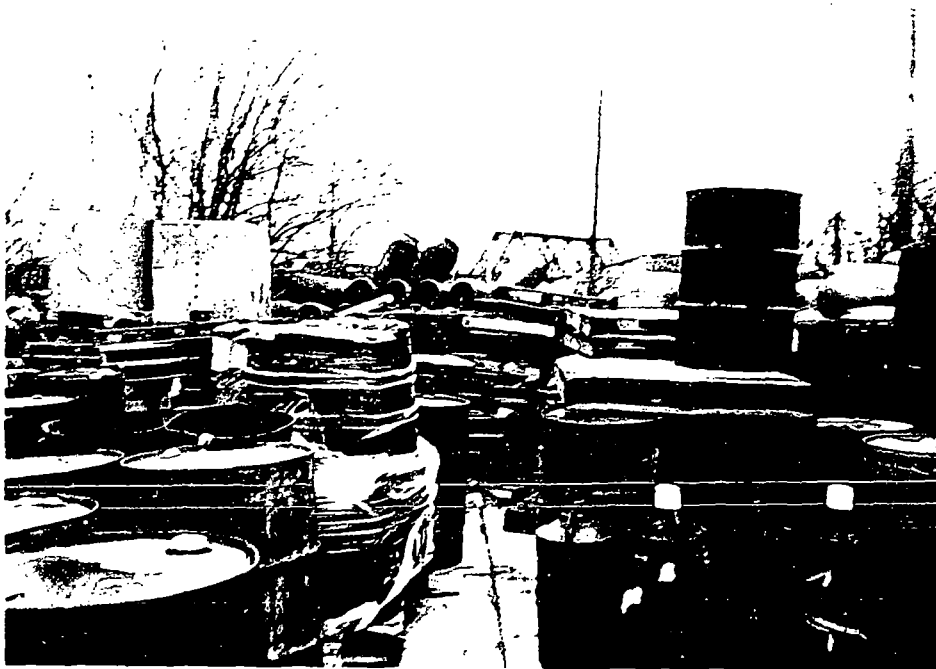
Photograph No. 4

Description: Deteriorating drums in the Operations and Storage Area.

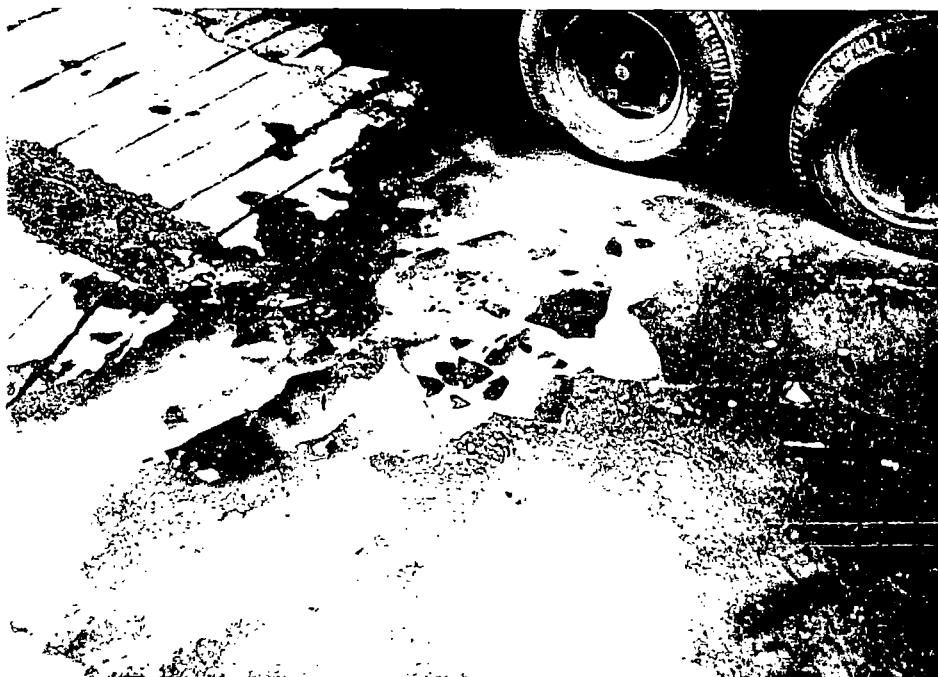
Photograph No. 6
 Orientation: Southeast
 Description: Milky white material at the truck loading dock area in the Operations and Storage Area.

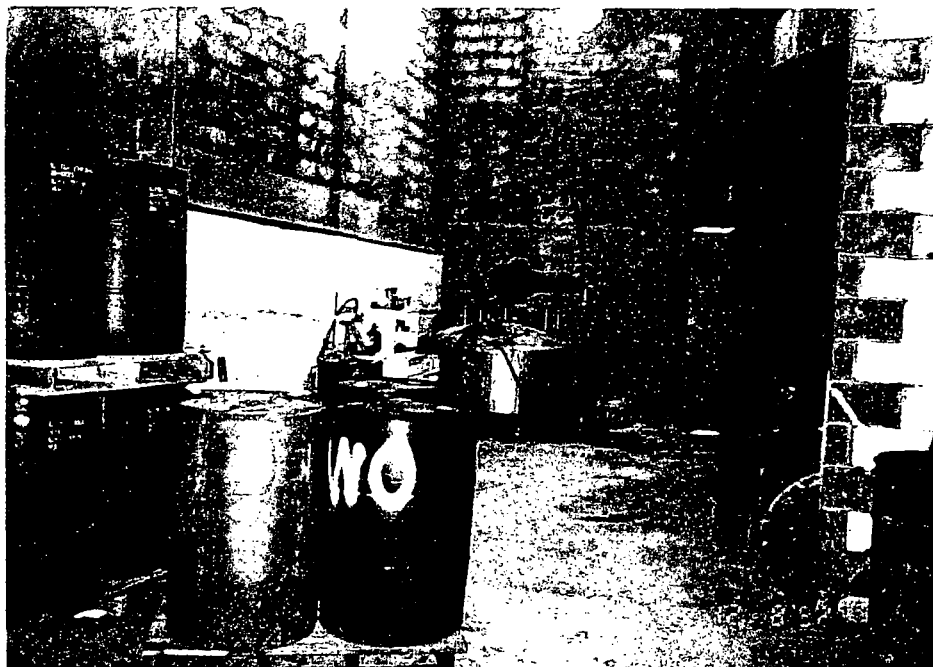
Observations: The area now contains a blending tank used by Orchem (see Photograph No. 7). The facility representative stated that Orchem had refurbished the area. No evidence of release was noted in the area.

Photograph No. 7
 Orientation: South
 Description: The location of the Former Chromate Destruction System.

PRC recommends no further action for this SWMU.
